River Pitt: Pitcombe to Cole, Somerset

Advisory Visit April 2025

This report is the output of a visit undertaken by Theo Pike of the Wild Trout Trust on approximately 1.5 km (0.9 miles) of the River Pitt in Somerset, from Pitcombe downstream to Cole, on 14 April 2025.

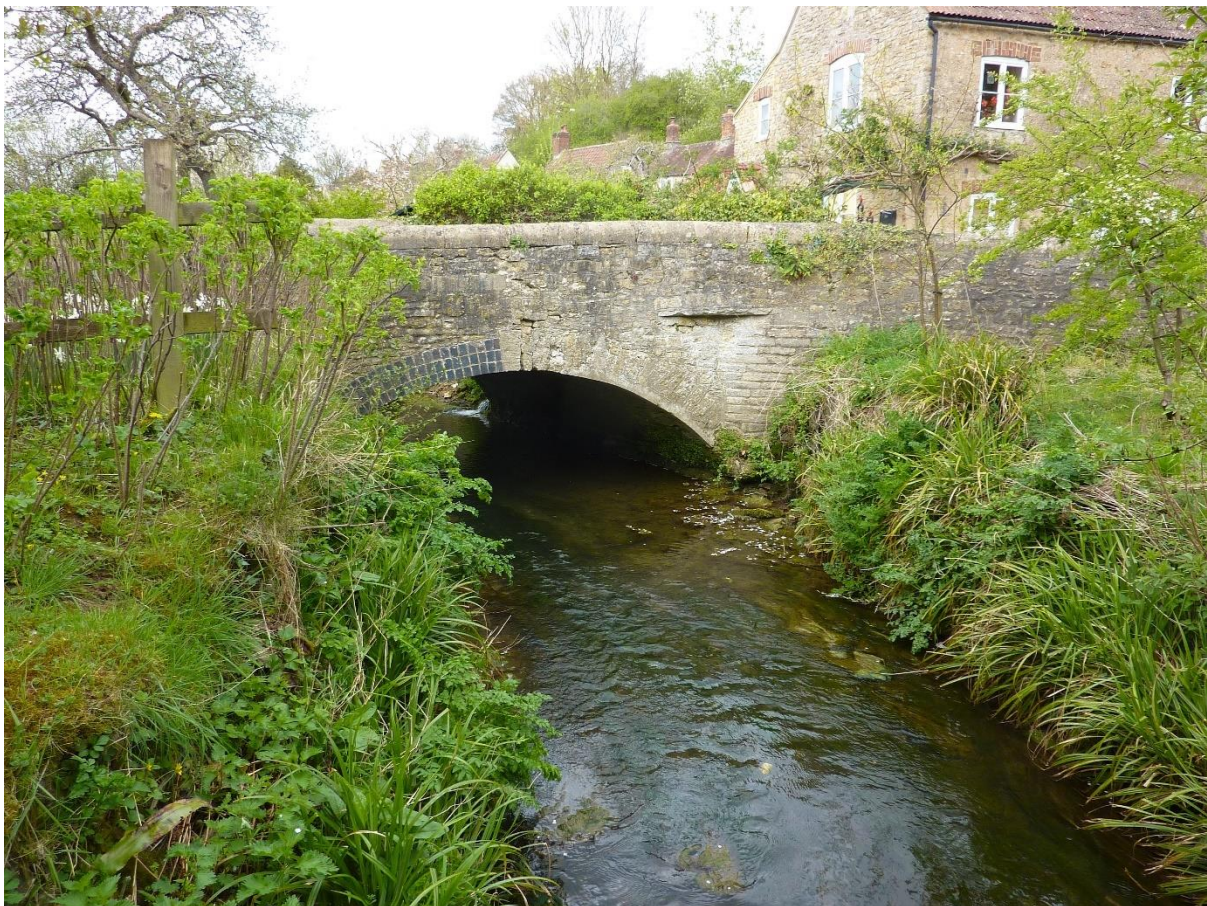
Figure 2: Pitcombe bridge, viewed from the gardens upstream

Along both banks of the river upstream of the bridge, a healthy fringe of sedges, water parsnip and other marginal plants was evident - offering plenty of low, trailing cover as habitat for trout and many other species, and providing a good example of how keeping a beneficially 'shaggy' (and light-touch, low-maintenance) river bank can easily be incorporated into the design of a traditional village garden.

At the time of this visit, it was noticeable that the gravel and cobbles in the river channel were thickly covered in mats of algae, possibly exacerbated by low flows and lengthening durations of sunlight, but also suggesting high levels of nutrients entering the river from sources further upstream.

These sources could include farm runoff, misconnections from domestic properties (when e.g. washing machines are mistakenly plumbed into rainwater pipes), and improperly-maintained septic tanks. The Rivers Trust's Sewage Map also shows a number of small, apparently unmonitored discharge points for treated sewage in the Shepton Montague area of the Pitt's upper catchment, so it may be worth investigating the performance of these sites with Wessex Water, or via a citizen science water testing scheme (including participation in the Brue CREW's wider riverfly monitoring programme).

This part of Pitcombe village lies in a relatively built-up area of the valley which is reported to be quick to flood at times of heavy or prolonged rainfall: the 'pinch point' of the single-arched bridge apparently causes high flows to back up before flowing around the ends of the bridge and partly flooding the adjacent Mill Lane (and sometimes at least two of the properties at its northern / upstream end before the gradient of the road rises just enough to protect the other houses). SC's flood investigation report also suggests that part of the bridge may be 'sinking into the river'.

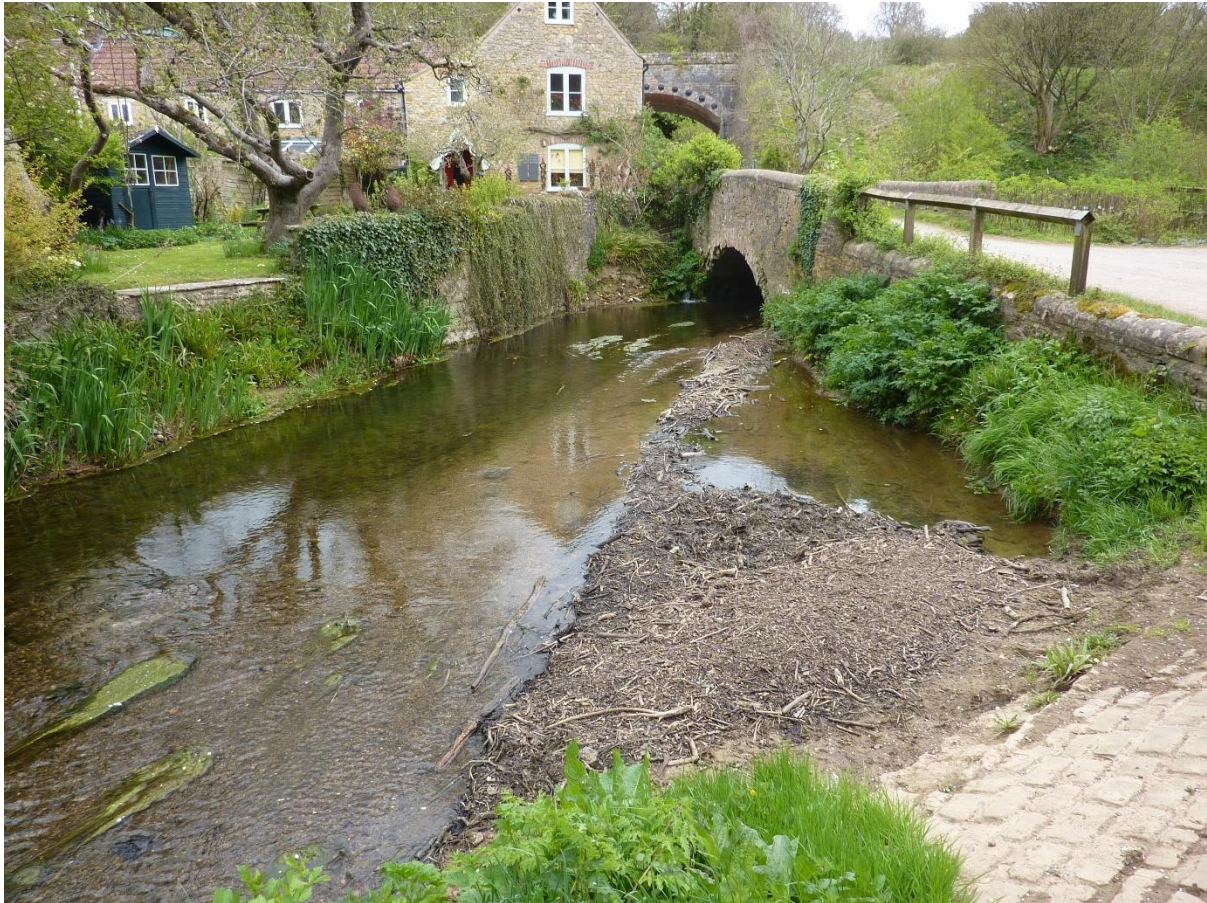
Figure 4: The River Pitt downstream of Pitcombe bridge, with a depositional area on the LB which would be suitable for naturalisation with native emergent plants

On the downstream side of the bridge, there is a wide area of shallow water (once perhaps an access ford for the cottages on the RB) with a depositional area on the inside bend of the LB where coarse woody material collects out of the river's main current.

This area is reported to be periodically cleared of collected sediments and woody material. For improved biodiversity as well as aesthetics, however, it would be preferable to leave much of this material in place, whilst adding a variety of ecologically valuable native emergent plants such as yellow flag iris, purple loosestrife, marsh marigold, water forget-me-not and water mint.

Establishing a range of colourful plants in this backwater area would provide a matrix of complex habitat which would be very valuable for small, weakly-swimming trout fry as well as other species, and is unlikely to make a significant difference to the channel's overall capacity and flood conveyance.

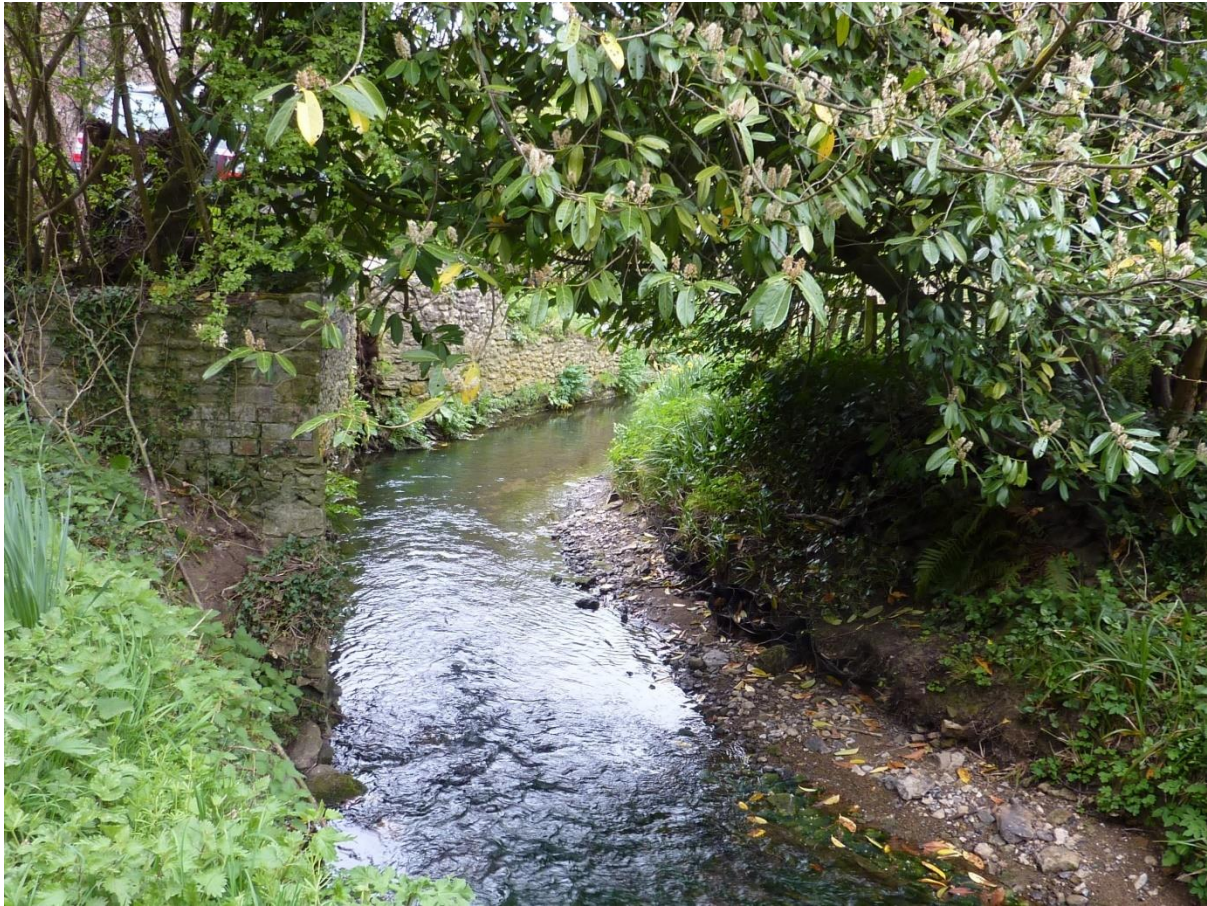
Figure 5: A pinch point in the River Pitt's channel at the upstream end of the gardens behind Mill Lane, over-shaded by a non-native cherry laurel tree

From ST 67221 33129, the channel of the River Pitt becomes much narrower, and flows in a steep-sided gully between the back gardens of the houses along Mill Lane.

As shown in the photo above, the upstream end of the channel is deeply over-shaded by a large cherry laurel tree on the RB. Cherry laurel is a potentially invasive non-native species (INNS) which offers very little habitat value for native insects and other species, partly due to its natural biochemical defences, including potentially poisonous levels of cyanide which can be released by pruning. Its seeds are also toxic to humans, pets and livestock. For all of these reasons, it would better be replaced with a specimen native tree such as hawthorn.

Observation at the time of this visit suggested that the narrowing channel and floodplain at ST 67221 33129 may potentially act in conjunction with the road bridge upstream as a second 'throttle' in high flow conditions, causing flood waters to back up towards the bridge again. This impression may be borne out by SSP's report on flooding issues in Pitcombe, which concludes from their modelling as follows:

As SSP's report suggests, it is likely that the present constrained form of the channel in this area is the unintended result of many years of piecemeal dredging and landscaping, and it is not easy to see how increasing channel capacity and 'making more space for water' to escape would be possible without modifying the gardens from ST 67221 33129 to ST 67206 33160.

However, reducing the slope of the LB to increase channel capacity could also offer an exciting opportunity to reimagine both the form and the function of the river through this area – perhaps creating a new and stable, naturally-meandering low-flow channel, well below the level of the houses and gardens on the RB, with attractively planted floodplain wetlands on one or both banks – offering significant biodiversity benefits as well as reducing flood risk.

Such a flood defence scheme could possibly be funded via Somerset Rivers Authority. Next steps could include commissioning an options appraisal and feasibility study, to verify the impacts of this second potential pinch point, and possible solutions, from a suitably qualified hydromorphologist.

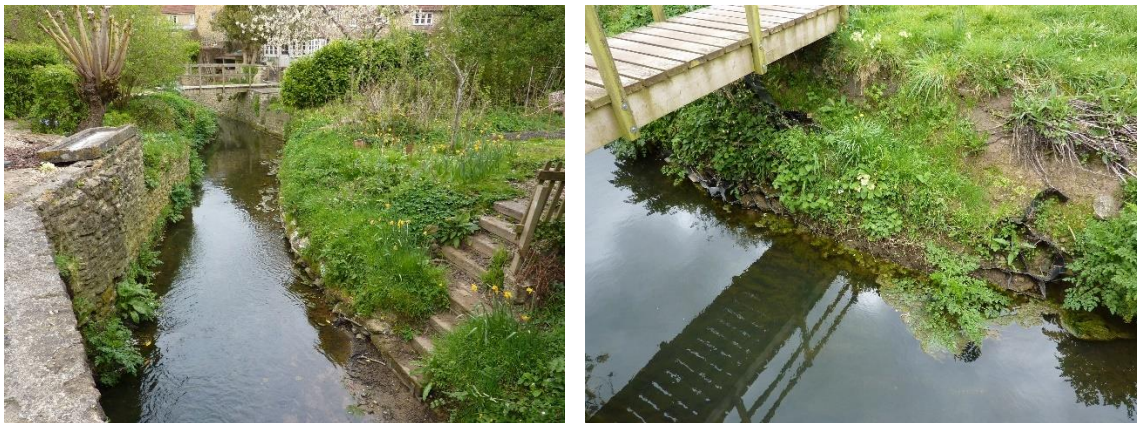
Downstream of this point, the river's plan form seems to retain a vestigial meander, which has been formalised with vertical rock revetments protecting the outside edges of its bends from erosion. On inside bends, attempts have been made to stabilise and vegetate over-steep banks with geocellular webbing, fixed with steel rebar and planted with various garden plants. In at least one area this webbing is now sloughing off the bank, having apparently become destabilised during recent high flows when a large 'dumpy bag' became caught under a small footbridge, forcing the river to scour downwards and outwards in this area (and incidentally also creating a new shallow riffle with the scoured-out gravels c 20m downstream).

Figure 6: The River Pitt's channel through the Mill Lane gardens: armoured with rock walls (left) and over-steep and slumping (right) despite attempts at vegetation with planted geocellular webbing

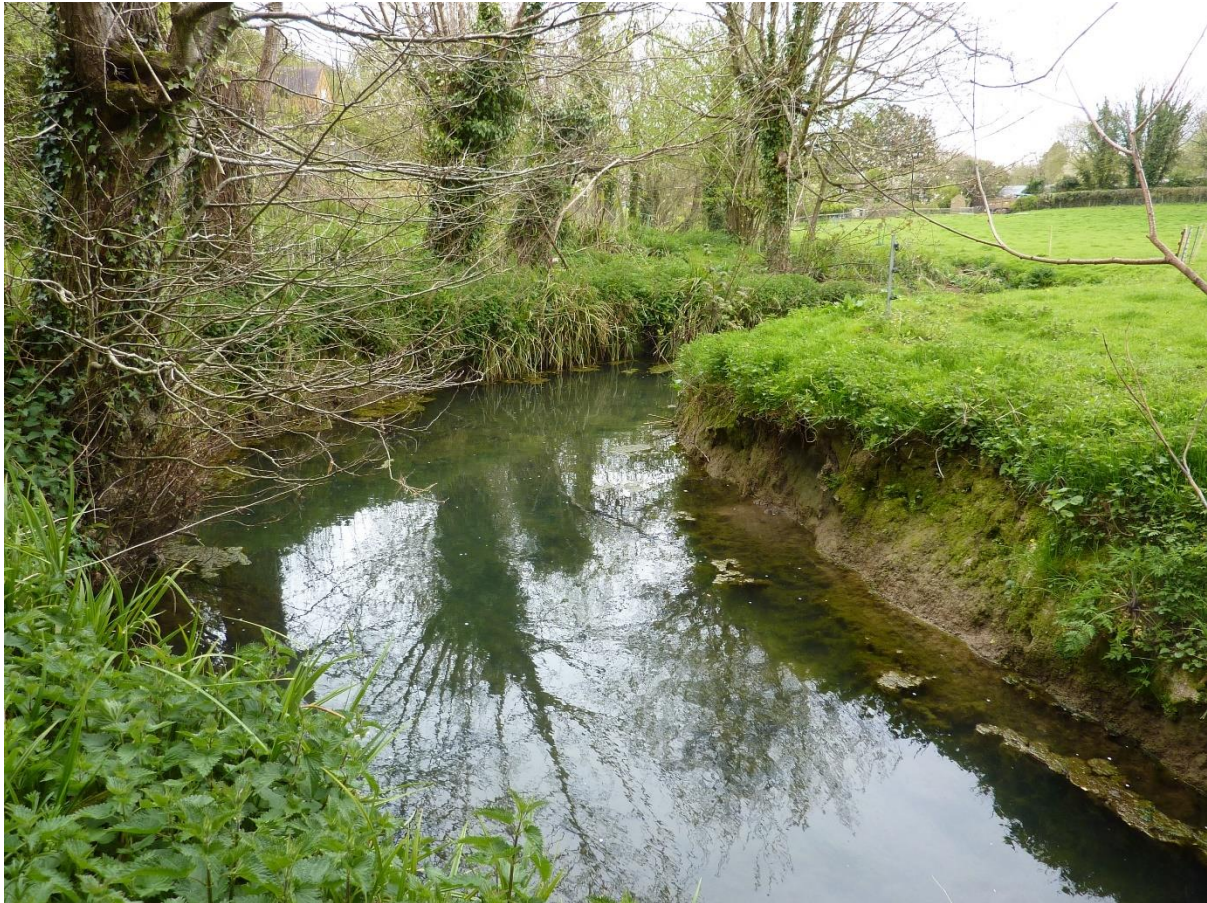
Figure 7: Looking upstream from ST 67147 33216: the river's RB is recovering some of its trailing vegetation following historic 'stream clearance' and dredging, but the square-profiled LB still lacks vegetation, partly due to grazing, and continues to be subject to block failure. Fencing off a 5-10m buffer strip, and perhaps regrading the angle of the bank, will help to ensure that the LB landowner will not continue to lose land to excessive erosion in future.

Throughout this stretch, the channel of the river is notably square in profile, with vertical banks and a flat bed, most likely as a result of past maintenance activities which are understood to have included dredging by the LB landowner, as well as annual community 'stream clearance' days when vegetation was removed from the channel in an attempt to improve conveyance. Areas of 'block failure' on the LB may also result from livestock grazing very close to the bank top – preventing grass and herbs from creating deep root structures, and restricting natural regeneration of trees whose roots would also reinforce the banks against excessive erosion. (It is understood that a number of mature trees were removed from this bank c 2012 in an attempt to improve conveyance of flood water across the floodplain).

From ST 67164 33201, where the woodland begins on the RB, marginal vegetation including shade-tolerant sedges appeared to be recovering – binding the banks as well as offering valuable low-level trailing cover for trout and other species – and indeed the RB landowner has often observed trout in this area.

In terms of future management, it is strongly suggested that such beneficially 'shaggy' marginal vegetation should be retained, and augmented wherever possible. Unfortunately, well-intended 'stream clearances' in the past are likely to have damaged the river's ecology (including dumping silt into the river from collapsing banks - smothering fish eggs and aquatic invertebrates) whilst producing very little benefit in terms of flood conveyance.

The landowner on the LB should also be encouraged to fence off a wide, ungrazed buffer strip at the top of the bank – at least 5m in width, and ideally 10m or more – to allow a healthy riparian fringe to develop, while providing alternative water sources so that animals have no need to cause additional erosion by trying to reach the water.

To accelerate ecological recovery, vertical banks could be regraded to a shallower angle (c 30 degrees) and planted with suitable deep-rooted native plants, facilitating the development of a gradual 'ecotone' which slopes from water to land, and would offer a much greater variety of habitats than the present failing vertical banks.

Suitable small trees on the RB could also be 'hinged' over and secured into the river margins (a process analogous to aquatic hedge-laying) to provide complex cover for fish, birds and invertebrates. If laid parallel to the bank, the additional 'hydraulic roughness' would also be very unlikely to significantly reduce flood conveyance. (See also comments below regarding the impoundment effect of Cole Manor Mill).

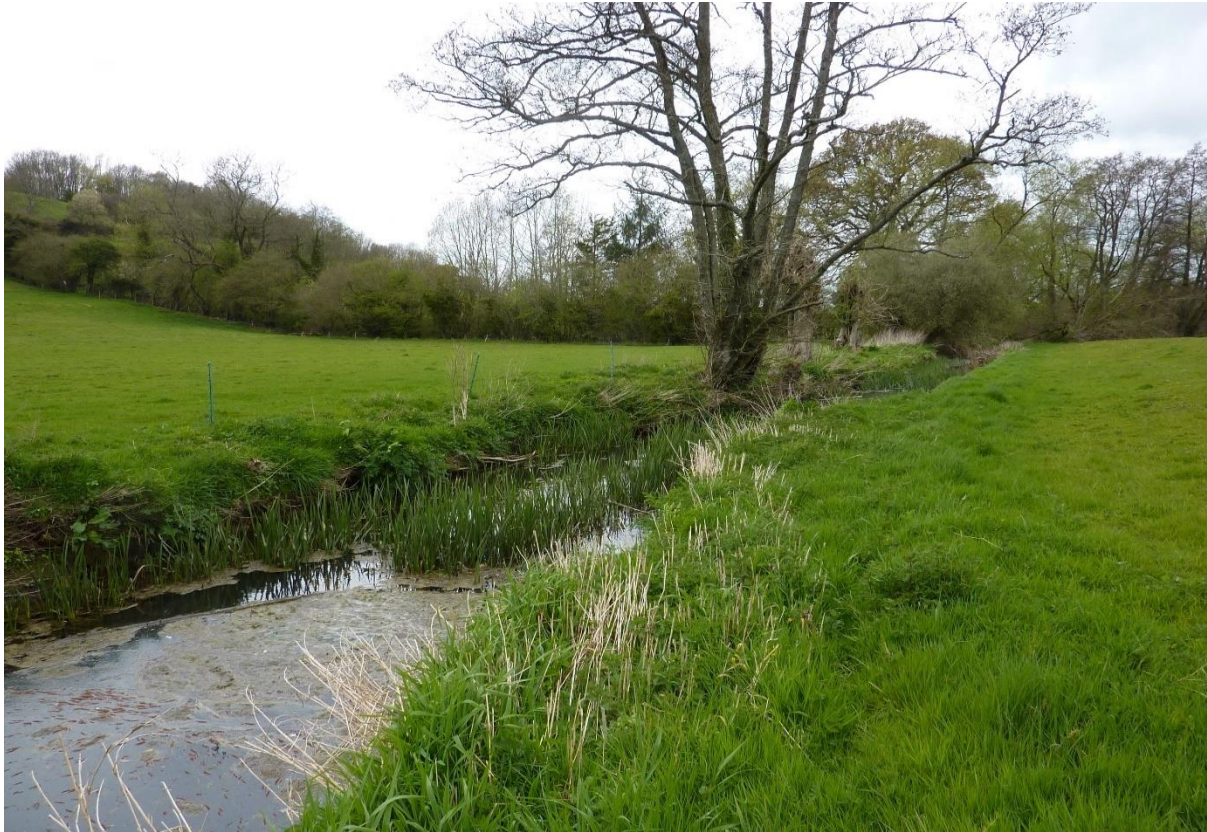
Figure 8: At ST 66982 33359 the river channel has been invaded by reeds, probably resulting from a combination of historic dredging and the continued 'ponding' effect of Cole Manor Mill further downstream

Between ST 67002 33319 and ST 66962 33387 the straightened channel suggests at least one past episode of dredging: the resulting over-deepened channel and lack of flow velocity may have resulted in excessive and uniform sediment deposition in this area, and the channel has been invaded with reeds which would not normally be able to tolerate higher flow velocities in a healthily-flowing mid-channel environment.

An additional factor in assessing this stretch of river may be the presence of Cole Manor Mill, c 0.5km downstream, and the upstream 'ponding' effect which its impoundment creates. This would also help to account for low water velocities and high sediment deposition, and illustrates how mills and their weirs can artificially raise water levels (and thus flood risk) for a long distance upstream. (It is understood that a similar indication was provided several years ago, when the mill's sluice gates were opened during a stream clearance event in Pitcombe village, and participants noted that the level of the river dropped significantly, even that far upstream).

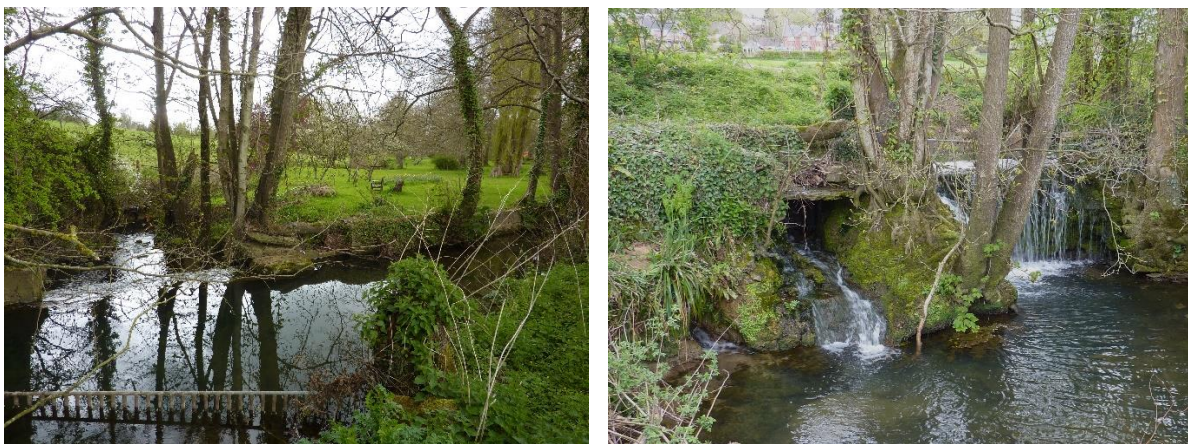
Figure 9: Cole Manor Mill head weir, seen from upstream (left) and downstream (right): a barrier to fish passage despite being in a state of disrepair. The pool below the weir offers habitat for adult trout, but the weir will block any efforts to migrate upstream

At ST 66961 33491, the flow of the River Pitt is split by the head weir of Cole Manor Mill. The site is believed to have hosted a mill since at least 1503; most recently, since the turn of the millennium, it has been converted to micro-hydropower generation as part of the South Somerset Hydropower Group.

In the case of the Cole Manor Mill head weir, on the day of this Advisory Visit, most of the river's flow was still directed towards the mill via a heavily silted high-level leat, with only limited flow over the crest of the weir into the main river (which may still follow part of an earlier course of the Pitt), and some additional flow via a sluice hole at the side of the main weir structure. Neither of these flow pathways is considered passable for trout and other fish at any height of water.

The leat is heavily shaded and filled with fine sediment, and offers very little habitat for trout. The weir's age is undetermined, but it is considered to be in a state of some disrepair - with mature trees growing out of it, and part of the sluice apparently blocked with a stone slab rather than with an adjustable sluice gate.

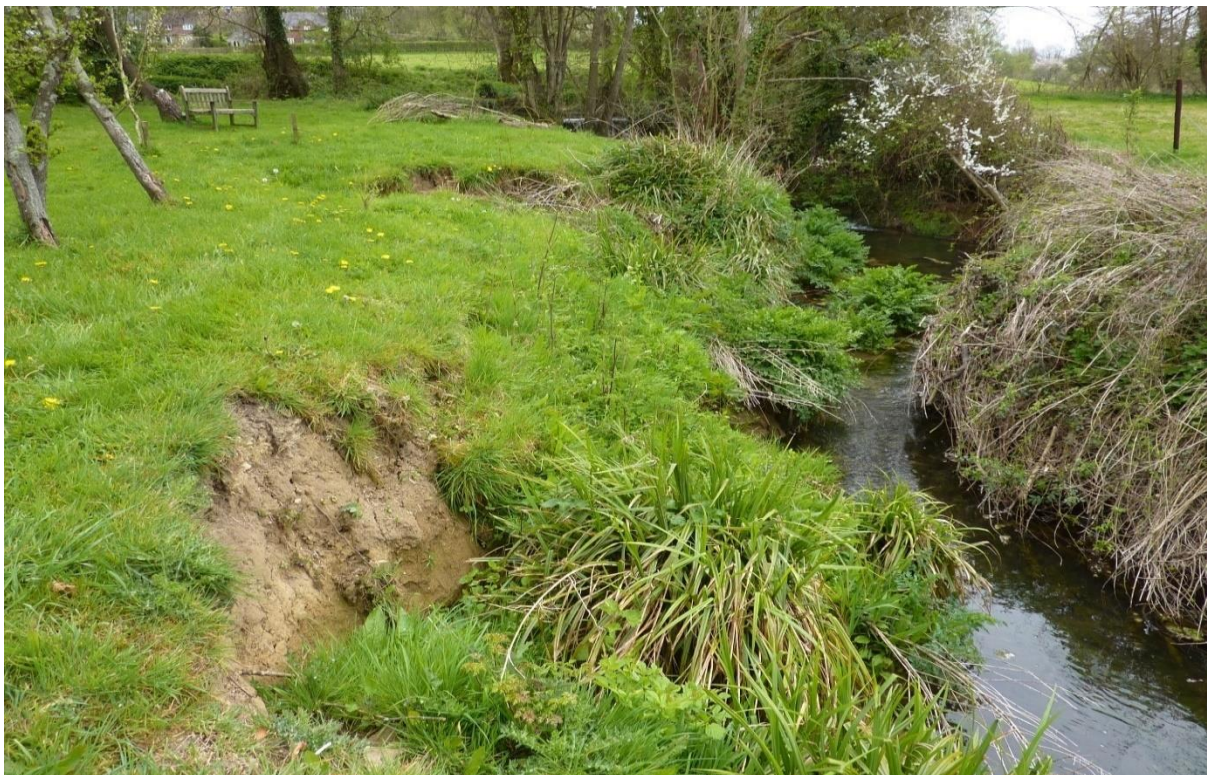
Figure 12: Two areas of bank failure on the main channel of the River Pitt in the Cole Manor Mill gardens, possibly associated with seepage from the higher-level leat

In the process of inspecting the weir and its wider surroundings, at least 3 small 'springs' were noted at separate points of the main river's RB near ST 66932 33513; a similar flow was also seen below and adjacent to the sluice gate on the head weir (as shown in Figure 9 (right) above).

Together with 2 seemingly associated areas of slumping of the main river's bank, these may suggest that seepage from the leat, which is artificially perched above the floor of the valley, is progressively undercutting the upstream end of the 'island' between the leat and the river. These areas of collapsing bank are already acting as point sources of sediment into the river, potentially smothering areas of gravel which would otherwise be suitable for trout spawning. They were also providing areas of bare soil for easy colonisation (and subsequent further

destabilisation) by invasive Himalayan balsam (see detailed discussion below) and perhaps other invasive non-native species (INNS).

Even more urgently, the possibility of catastrophic failure (landslip) of this whole area at any time - particularly in high flow conditions, as the river attempts to reclaim its natural course through the valley - should provide impetus for investigating (via SC and the EA in the first instance) a more controlled approach to removing the weir and its impoundment completely. This would help to reduce flood risk both up and downstream, and would be the best solution by far for the river and its ecology.

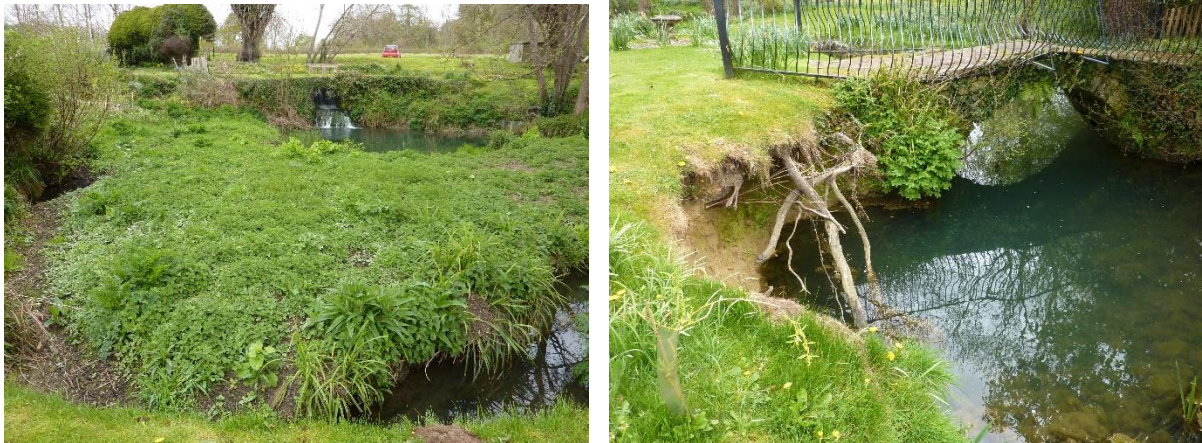
Figure 13: Cole Manor gardens: the silted ornamental pond (left - with a sluice gate from the mill leat visible in the background) and erosion caused by a back eddy from the abutments of a footbridge (right)

Moving downstream through the gardens of Cole Manor Mill, a number of structures were noted which relate to the mill's working past. One of these, at ST 66861 33631, was a heavily-silted ornamental pond, situated below a relief sluice in the side of the mill leat: this pond is apparently scheduled for desilting and restoration as a flood storage basin as well as an ornamental feature. In the event that the head weir (and thus the flow of water along the leat) is removed, it could still function very beneficially as backwater habitat for fish, birds, insects and amphibians.

At ST 66837 33619, the main channel of the River Pitt was pinched by the abutments of a small footbridge. Water swirling in a back eddy on the downstream side of the bridge has created a deepening area of erosion on the RB. Although the bank may have been strengthened for some time by a structure of thick roots (from a tree which is no longer present in this area), the developing area of erosion may eventually threaten the bridge; in the meantime it is also eroding fine sediment into the river.

To halt this excessive erosion and sustainably repair the bank line, a 'green engineering' approach is advised: staking brushwood bundles or a hazel lattice (whose complex structure will dissipate the energy of swirling currents) across the embayment, before back filling with further brushwood and locally-sourced limestone cobbles and gravel, and planting the area with deep rooted plants, including goat willow.

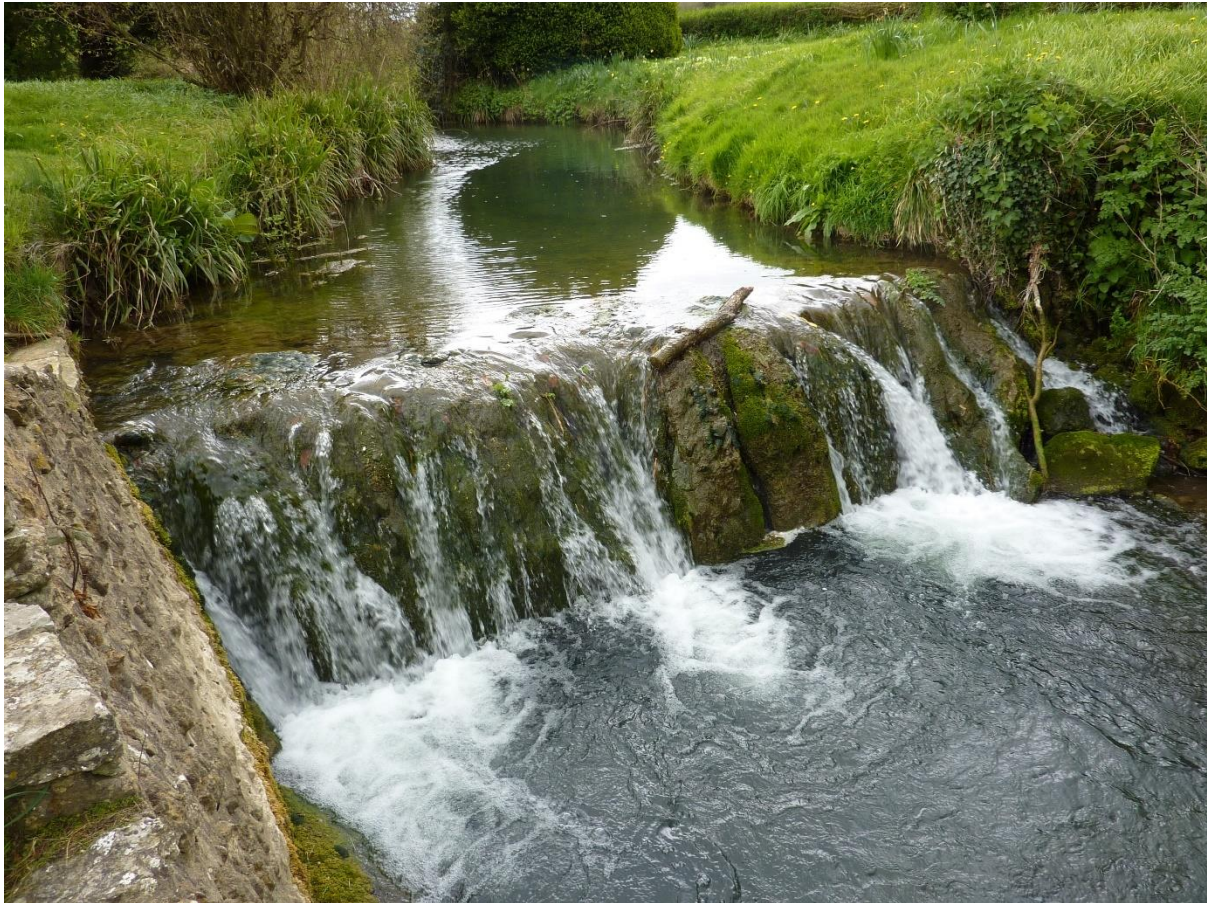
Figure 14: Cole Manor gardens weir: smaller than the head weir, but still an obstruction to fish passage and sediment transport

At ST 66792 33657 a further weir was observed, just upstream from the formally landscaped outflow channel from Cole Manor Mill, with particularly thick growths of algae in the slow-moving water exposed to sunlight upstream of the structure. Although this weir is lower and less vertical than the head weir discussed above, it still constitutes an obstruction to fish passage and natural sediment transport, and should similarly be removed for the health of the river, its fish and other species.

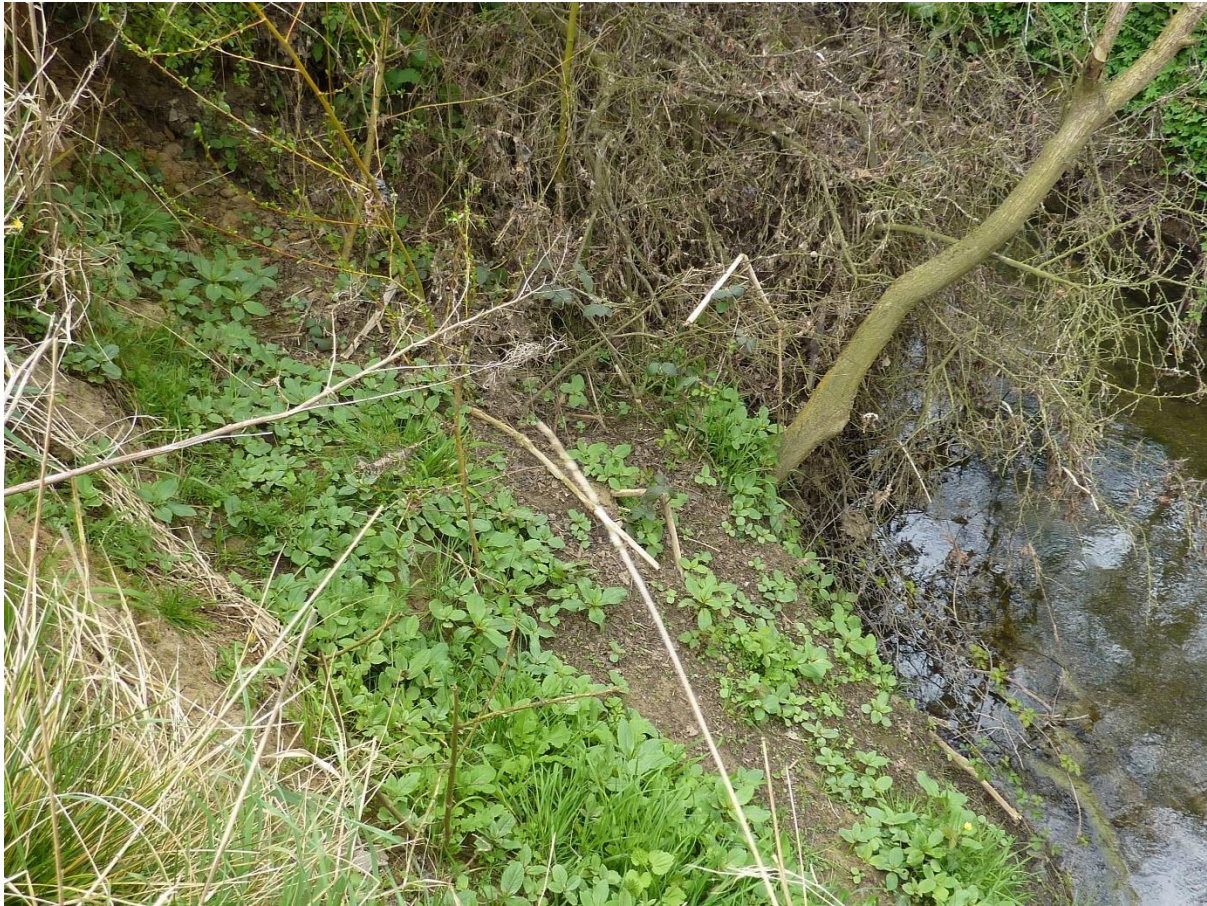
Figure 15: Himalayan balsam seedlings on the river bank at Cole Manor: note how previous years' growth has suppressed native plants, making the bank more prone to erosion

At several points along the river banks in the gardens of Cole Manor Mill, as well as in the grounds of Cole Manor further downstream, abundant quantities of young Himalayan balsam (HB) seedlings were seen. HB is a damaging invasive non-native species (INNS): a tall, shallow-rooted plant which spreads with floating, spring-loaded seeds which can be ejected up to 7m from the parent plant. It grows in dense monoculture stands that shade out native species before dying back in winter, leaving bare soil without perennial root structure to help resist erosion. River bank erosion can contribute significantly to river bed sedimentation (one recent study suggests a rate of 10 tonnes per km per year) smothering gravels, invertebrates and fish eggs. More generally, HB also reduces biodiversity by suppressing native plants with allelopathic compounds in the soil and attracting insects to pollinate its flowers preferentially with its strong scent and prolific nectar.

Extensive areas of HB monoculture can be brought under control by repeated strimming or mowing, with hand-pulling as a follow-up measure. For smaller areas, or greater selectivity when HB is growing among other more desirable plants, hand-pulling is a tried and tested means of control and eventual eradication, as well as an excellent form of community engagement.

For sustainable long-term results, a catchment-scale approach is required: the furthest upstream extent of the infestation should be located, with a systematic

programme of eradication designed to progressively push HB further and further downstream, and eventually out of the catchment completely.

In general, HB seeds appear to survive in the soil for around 3 years, so it may be necessary to revisit previously infested areas for at least this length of time. For best results, areas of infestation should also be revisited repeatedly through the growing season, up to the time of the first frosts in autumn, to prevent late-germinating plants from flowering and setting a seed bank for the next year.

Once pulled or strimmed, HB plants should be piled up to compost well away from any watercourses, with the stems snapped between the root and the first node of the stem to prevent resprouting: the fleshy plants will desiccate quickly, and experience shows that few seeds will survive this process to germinate in future years.

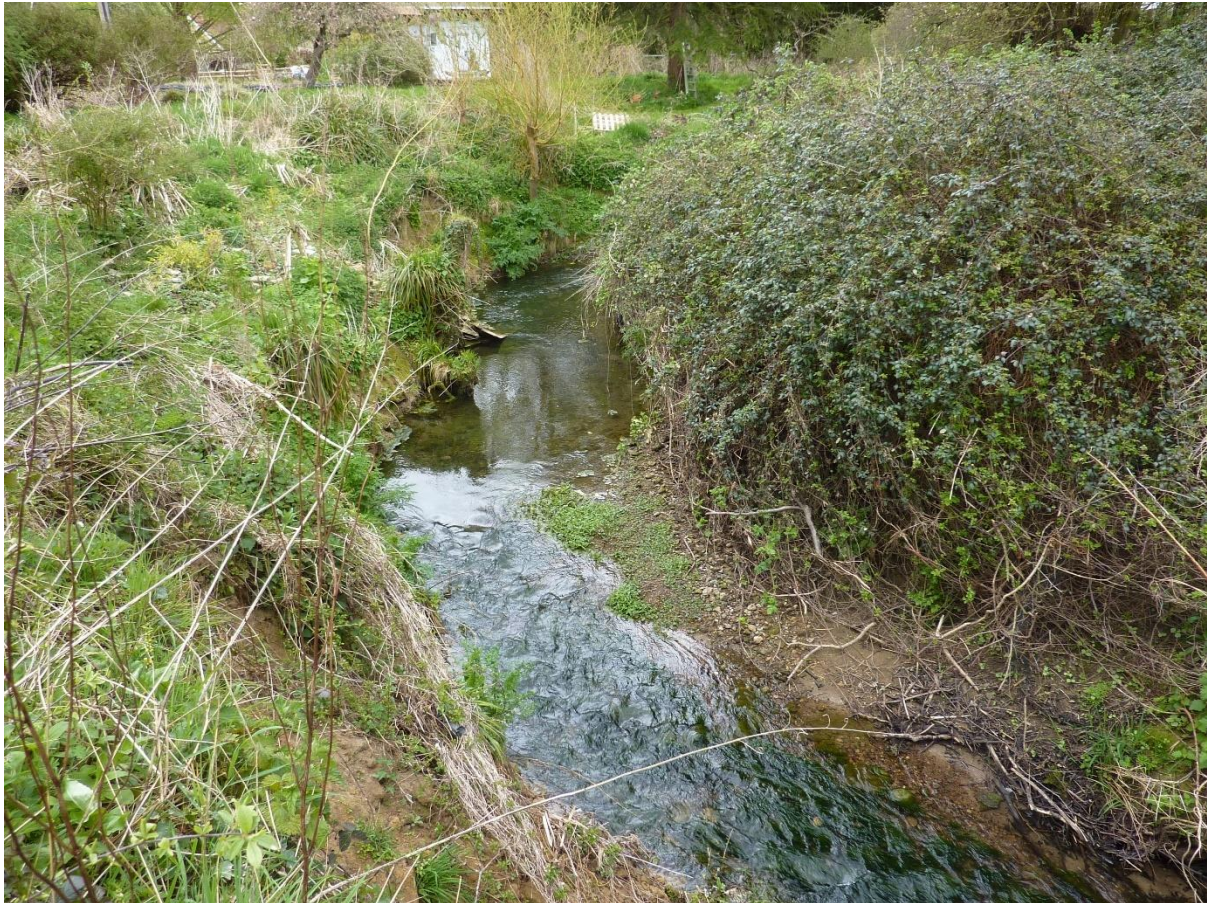
Figure 16: A pool and riffle sequence on the River Pitt at Cole Manor: this natural river structure maximises habitat niches for many species including wild trout

The gradient of this stretch of river is relatively steep, with a pronounced pool and riffle sequence which offers excellent habitat for all stages of the trout life cycle – including spawning opportunities in an abundance of fine gravel within the brown trout's preferred size range of 10-40mm. Together with trailing marginal vegetation, and diverse emergent native plants such as water cress, these features could offer a reference for restoring other reaches of the River Pitt.
