River Brue: Gants Mill (Bruton) to Cole, Somerset

Advisory Visit April 2025

Theo Pike: tpike@wildtrout.org

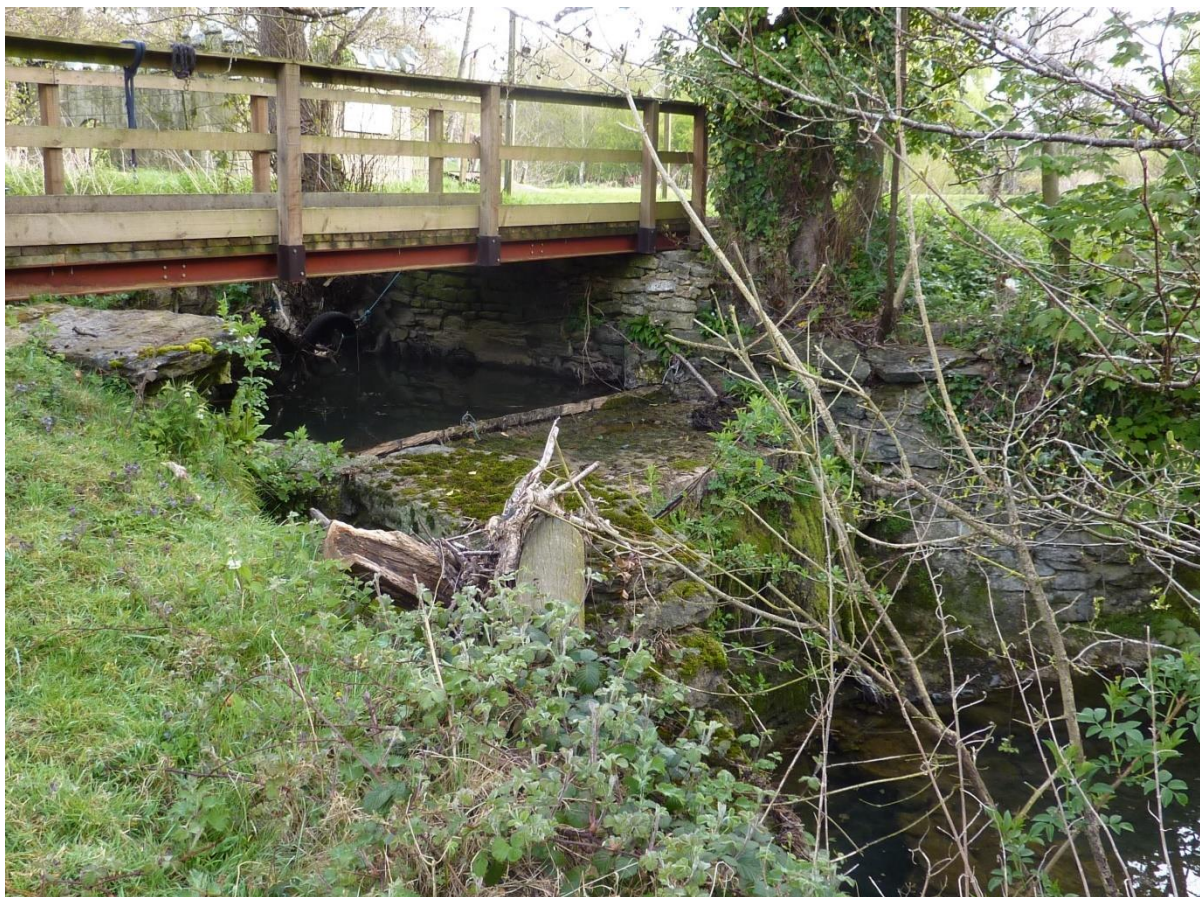
Figure 2: The Island weir: impassable to fish at all flows, and allowing almost no water into the main channel of the River Brue through the Gants Mill estate at the time of this visit

During this walkover, it was noted that the structure of the Island weir probably represented several stages of construction and repair, with some of these

measures visibly deteriorating - particularly in the case of the wing wall on the RB. Due to the sluice gates at Gants Mill having been temporarily lifted out for repair, proportional flows into the river were so low that no water at all was passing over the sill of the weir, but a very minimal flow still appeared to be making its way through or around the structure at a lower level. This suggests that the Island weir may already be vulnerable to failure when further stressed by high flows. Further investigation is recommended as a matter of some urgency; any plans for repairs, in addition to balancing flows between the mill leat and the main river, should also include discussion of opportunities for improving fish passage through this whole area – including options for removing the deteriorating weir altogether (which may also be cheaper than repair).

In the meantime, a deteriorating wooden stop board was observed on the sill of the weir, which may be directing available flows towards the leat and / or into vulnerable areas of the weir itself. It is recommended that this should be removed as soon as possible.

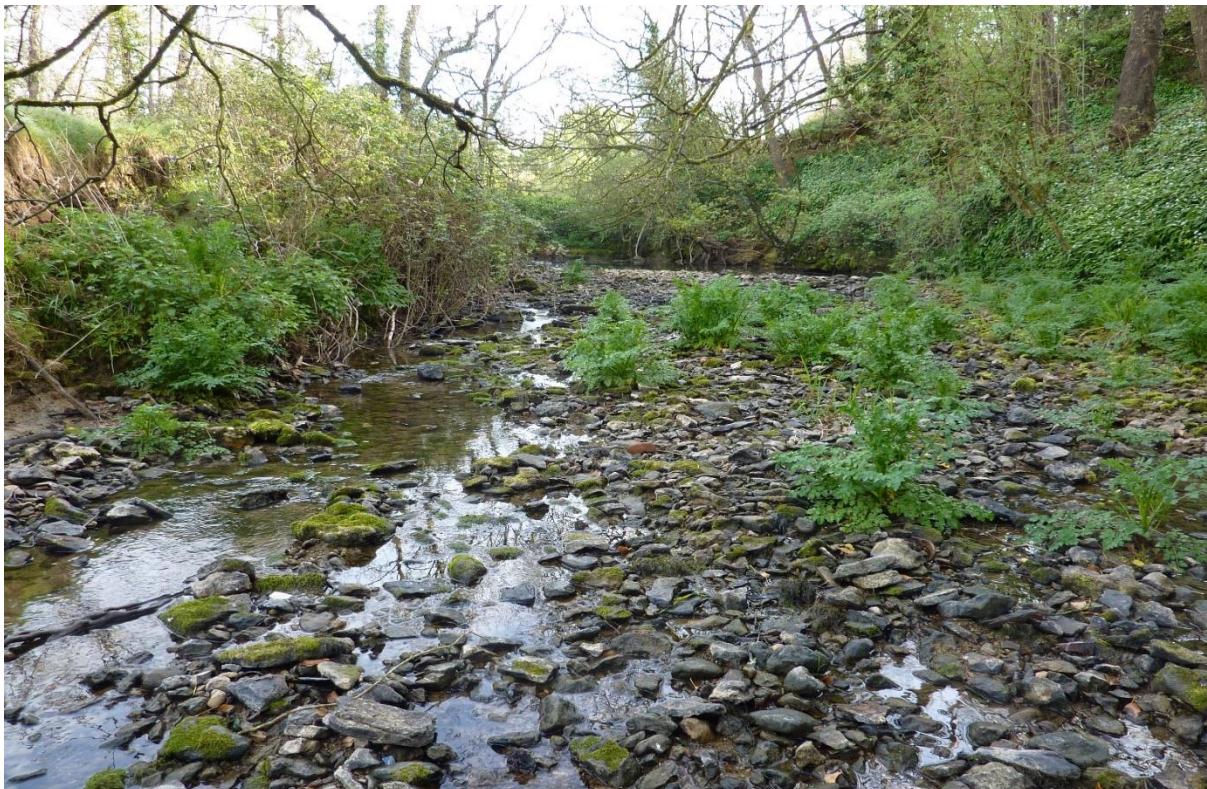
Figure 4: The River Brue downstream of Island weir: severely depleted flows, and river sediments dominated by unsorted cobbles

Many of these impacts can be seen in the main channel of the River Brue downstream of the Island weir. Very low flows reveal how the river's substrate is dominated by unsorted cobbles whilst being depleted of finer gravels, which have either become trapped behind the Island weir or moved straight into the mill leat (which appears to be comparatively well supplied with pea-sized and slightly larger gravels, suitable for spawning by trout and other fish). Brown trout require clean and well-sorted gravel, generally in the size range of 10-40mm.

To tackle this suite of issues, consideration should be given to gravel augmentation (introducing large volumes of geologically appropriate gravel to the river channel just downstream of the Island weir, and allowing the river to redistribute it further downstream); fencing livestock off the top of the river bank (creating a buffer strip of at least 5m - ideally 10m or more - between fence and the present bank top, and providing alternative water sources so that animals have no need to cause additional erosion by trying to reach the water); and working with community groups like the Brue CREW to tackle HB across the Gants Mill site as part of their strategy to eradicate it throughout the upper catchment.

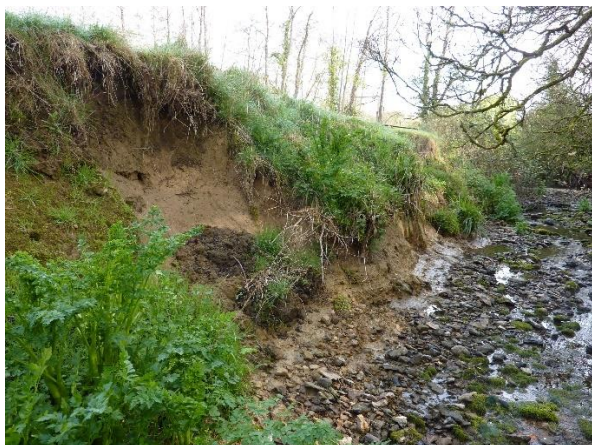
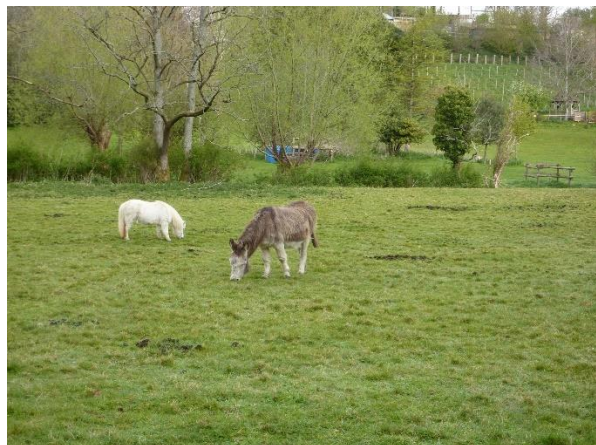
Figure 6: Block failure of over-steep banks (left); livestock grazing on the Island (right)

Additionally, periodic rapid variations in flow - from regular dewatering caused by diversion of flow for milling and micro-hydro activities, to very high scouring spates at times when higher rainfall has led to significant overtopping of the Island weir - appear to have caused excessive bank erosion and even 'block failure' of the banks in some areas downstream of the Island weir. Erosion is a natural

Regrading and stabilising the river banks in this area could also be investigated as part of other works on the Island weir site: for example, by incorporating reprofiled banks into a general programme of fish passage improvements and channel renaturalisation.

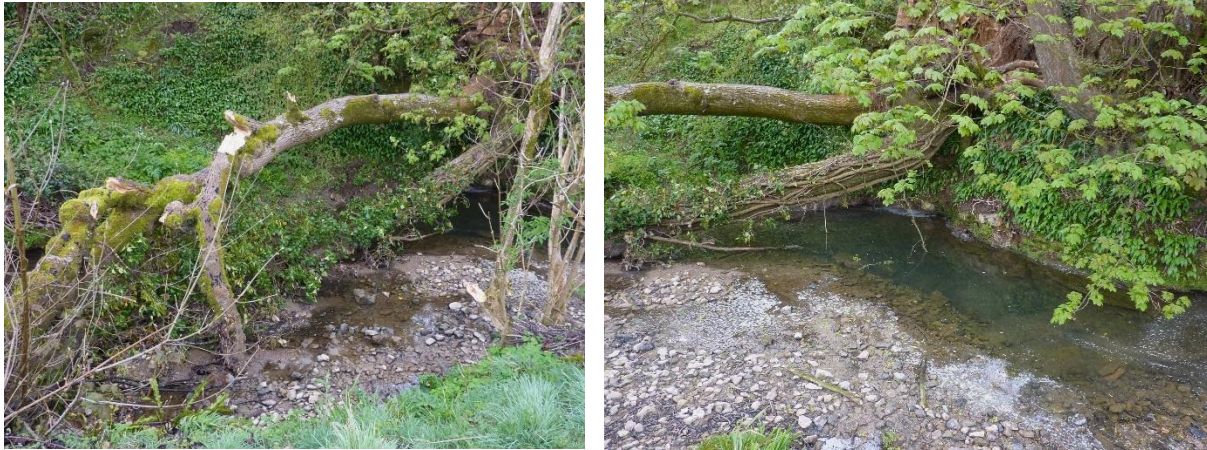
Figure 7: Benefits of large woody material: A fallen ash tree in the river is delivering habitat benefits such as trapping silt and 'sorting' gravels (left) as well as helping to maintain a deep scour pool, with the kind of overhead cover that trout love (right)

Proceeding downstream alongside the Island, at least one large ash tree (possibly affected by ash dieback disease) was observed to have fallen into the river from the LB.

These natural benefits mean that trees which fall into rivers should always be left in place and kept under observation, unless they are causing an immediate and obvious flood risk. If the channel is genuinely at risk of becoming blocked, with important infrastructure threatened, a good compromise may be to leave the wood in the river, but winch the tree parallel to the bank so that the risk is reduced and the hydromorphological benefits are retained.

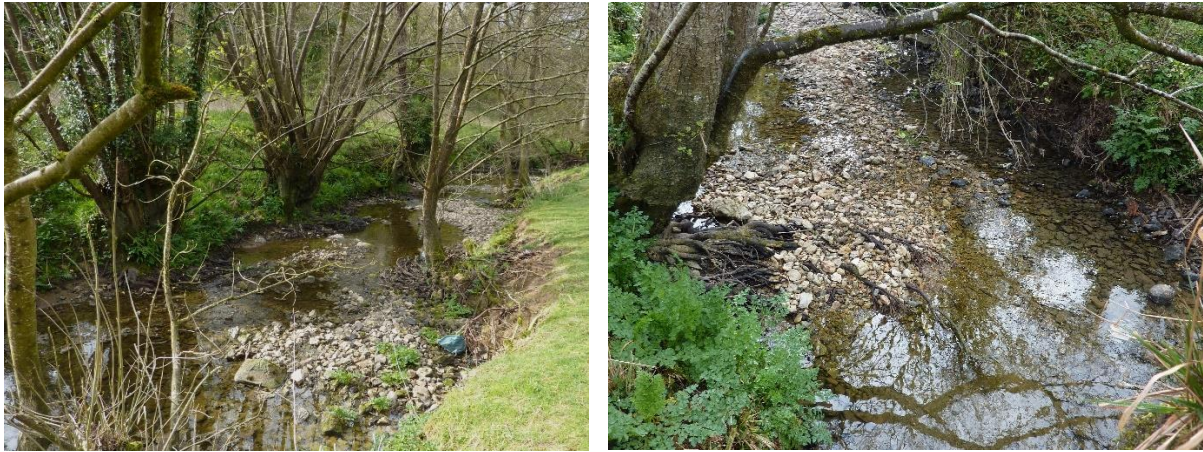
Figure 8: Subsurface tree roots provide cover for fish as well as 'forcing' scour and deposition; note the tree root structures still helping to reinforce the RB, although this also seems to be grazed and would benefit from fencing and revegetating (including targeted tree planting for future hinging down into eroded areas of bank)

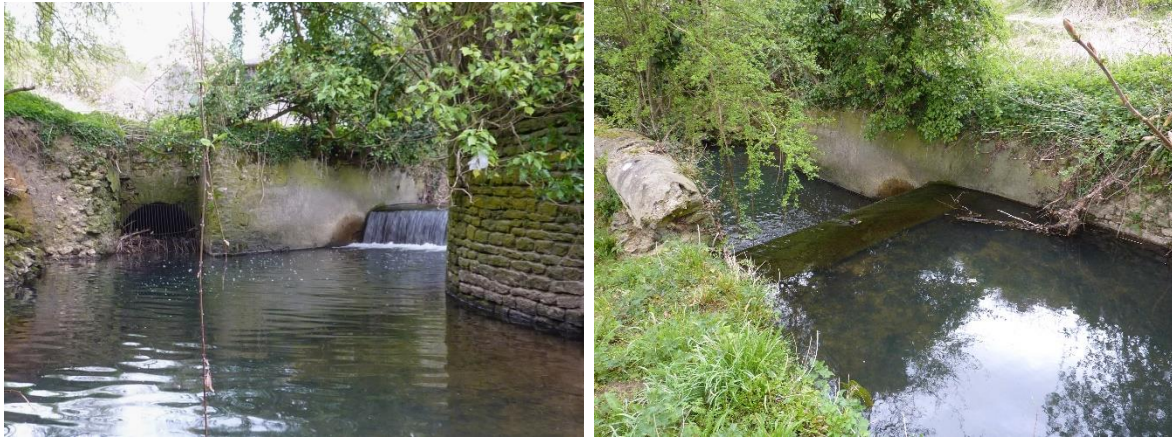
Figure 9: Views of Farm weir from downstream (left) and upstream (right)

As the main channel of the river approaches the Gants Mill access bridge at ST 67454 34211, it becomes impounded by another weir (hereinafter dubbed Farm weir) which is located further downstream at ST 67382 34229. The mill leat also rejoins the main river at ST 67432 34217, and appears to be similarly impounded by this weir, possibly all the way upstream into the mill tail pool shown on the front cover of this report.

Ironically, under the present flow regime, this artificial impoundment (and the connected mill tail pool) appears to be providing some deep-water refuge for trout and other fish species. Although restoring the natural flow of the main river will undoubtedly provide much more viable habitat throughout the presently dewatered reach alongside the Island, consideration should also be given to helping the river to re-establish a healthy sequence of deeper pools throughout the Gants Mill stretch of the river. This may be achievable by increasing the volume of LWM in the channel, both by retaining naturally fallen timber and by strategically felling trees into areas where deep scour holes, subsequently created by the action of high flows, might be most beneficial.

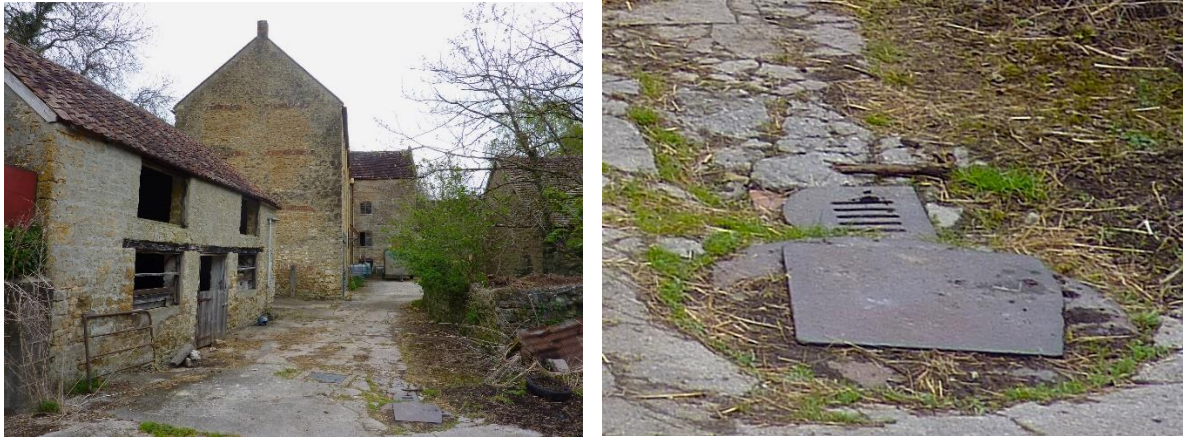
Figure 10: Gants Mill buildings being used for agricultural purposes; the cast iron drain grate could carry contaminated water directly into the river

At Gants Mill, some of the former fabric mill buildings have been informally repurposed for farming, including shelter for sheep. When the mill's original rainwater drainage system was installed, this would have been designed to convey water straight to the river. With livestock now in residence, runoff from this makeshift farmyard could constitute a point source of pollution for the river, including fine sediment, faeces and pharmaceuticals.

At the time of this visit, dry weather meant that it was difficult to confirm flow pathways in and around buildings being used for stock shelter. Further investigation via a 'wet weather walk' is recommended, followed by efforts to separate clean and dirty rain water, in the event that the former mill buildings continue to be used for agricultural purposes. In the meantime, measures should also be taken to ensure that no slurry and dirty bedding is accumulated near the river, where additional runoff could cause pollution.

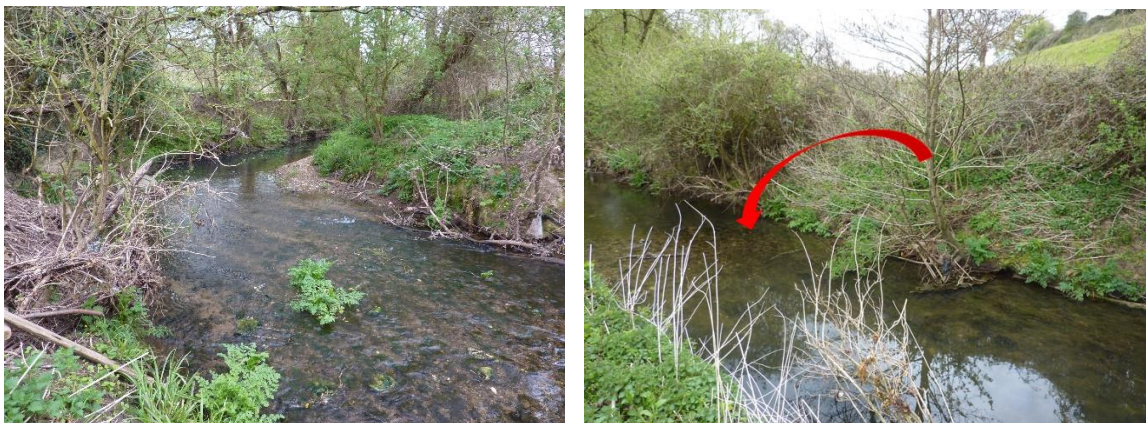
Figure 11: At the downstream end of the Gants Mill reach, the river has a healthy pool and riffle sequence (left); an example of a small alder tree which could be hinged over into the margins to augment valuable cover for many species (right)

Downstream of the farmyard and the Farm weir at ST 67382 34229, and having regained the flow from the Gants Mill leat, the channel of the River Brue becomes increasingly naturalised, with the river's characteristically incised clay banks, but

Low, shaggy, trailing vegetation was abundant, and a number of opportunities were noted for hinging small trees into the margins to provide additional complex bankside cover (it was noted that some of these may be on neighbouring riparian owners' land, so some collaboration may be necessary to get the best results for the river). The RB had a healthily vegetated buffer between the river and the bank top, while the field on the LB is regularly used for grazing: fencing off the LB bank top and providing drinkers would be beneficial, in order to allow a diverse riparian fringe to re-establish, including succession of naturally seeded trees.

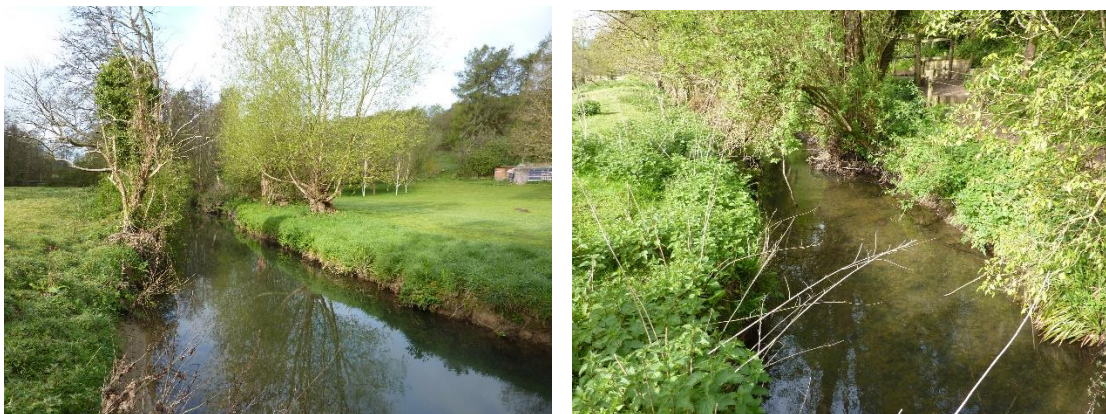
Figure 12: Views of Gants Mill leat

The leat which has historically carried water from the upstream end of the Island to Gants Mill is an engineered channel which continues the artificial straight line of the main river upstream of Island weir, and is perched high above the natural valley floor. Over time, despite probable flow variations linked to milling and hydropower, this has become naturalised, and may even offer some very limited areas of trout spawning and juvenile habitat. However, this should not be regarded as a reason to continue to deprive the main river of ecologically important perennial flows.

Alongside the Island, the leat was observed to be deep and possibly dredged in the past. At ST 67702 34354, an overflow channel appears to be designed to convey excess water to the main river; from this point downstream to Gants Mill, the leat becomes increasingly perched yet also heavily incised, creating a linear mill pond for the mill.

As noted above, some areas of the leat appear to be reasonably well supplied with smaller gravels than are widely present in the main river: it is possible that these could be used as a guide to the type and sizes required to augment the main channel. In future, when the new flow regime is implemented, the leat is unlikely to offer good trout habitat, but it could still provide ecological benefits as a valuable low-flow wetland for aquatic invertebrates and amphibians.

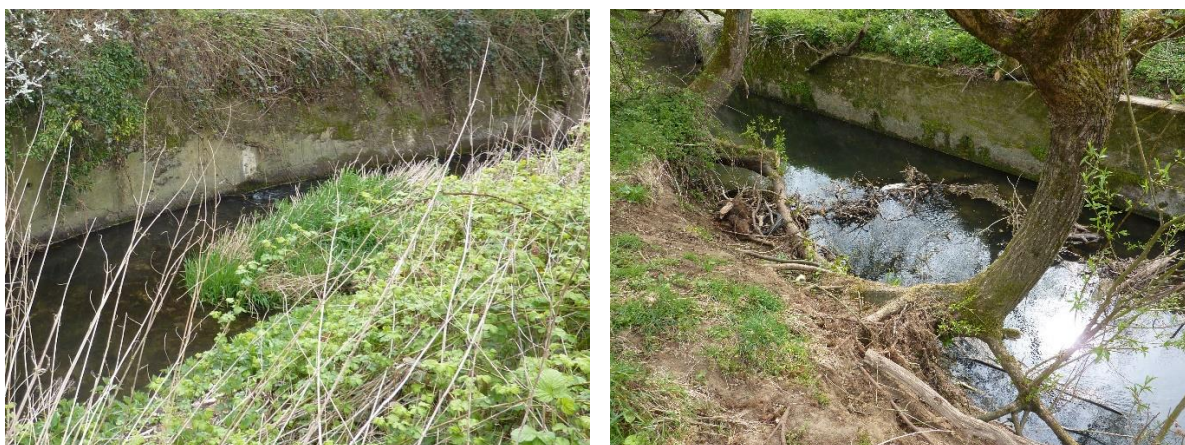
Figure 13: A mid-channel island forming ecologically valuable islands opposite the concrete STW wall (left) and crack willows offering bankside erosion protection and habitat (right)

In the channel, it was interesting to see that a small number of low-level mid-channel islands had formed, perhaps initiated by sediment collecting around emergent vegetation such as water parsnip, and then becoming colonised by reed canary grass and other species. Similar features can also be observed on other human-modified stretches of the Brue, such as in the middle of Bruton: they provide valuable complex habitat for many species, and any attempt to remove these islands (thus 'simplifying' the channel and reducing its structural diversity and habitat value) should be resisted.

Crack willows were also growing on the RB at several points, and at least one of these had fallen, re-rooted, and continued to grow – providing robust habitat and natural bank reinforcement against excessive erosion. Crack willows grow quickly and tend to grow unmanageably large before splitting and falling, and it may be preferable to coppice or pollard some of these on a rotational basis if there is a likelihood that they will fall across the river onto the STW site. Future replacement planting with smaller, more manageable goat willows could also be considered.

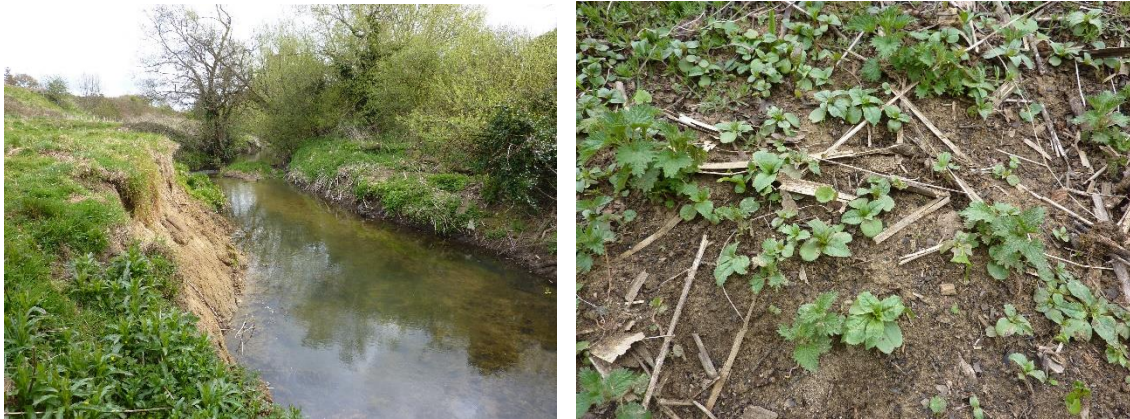
Figure 14: An area of excessive erosion (left) and Himalayan balsam seedlings (right)

Apart from providing very little habitat, hard infrastructure such as the concrete revetment alongside Bruton STW is unable to dissipate the energy of flood flows in the way that 'shaggier' natural river banks would – instead transferring the energy downstream where its erosive force is all the greater. This appears to be happening around ST 67041 33857, where a section of RB (also apparently lacking deep vegetative root structures to hold it in place) is progressively failing and collapsing into the channel, which is now becoming silty and overwide.

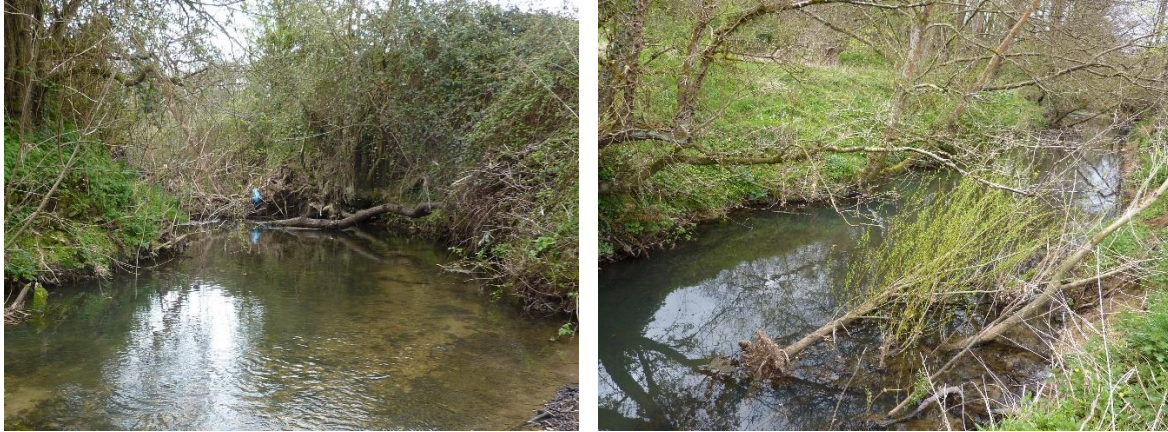
Figure 15: Beneficial large woody material in the channel

Further downstream, between the STW and the Colestile Farm Lane bridge, at least one very beneficial accumulation of LWM was noted in the channel. Due to over-zealous past flood risk management and over-tidying, many UK rivers are still 'functionally starved' of LWM, which would naturally be deposited by processes such as wind-blow or beaver activity. As noted above in this report, LWM 'drives' many essential processes like localised scour and deposition of sediment, as well as providing complex cover for fish and birds, and surface area for aquatic insects. Whenever possible, such LWM should be left in place as a valuable 'gift from nature'.

As seen in the photo above (left), LWM can sometimes trap plastic and other human litter: while this may create an aesthetic eyesore, it also makes collection easier for landowners and volunteers, thus preventing these materials from being swept out to sea as marine plastic and other pollution.

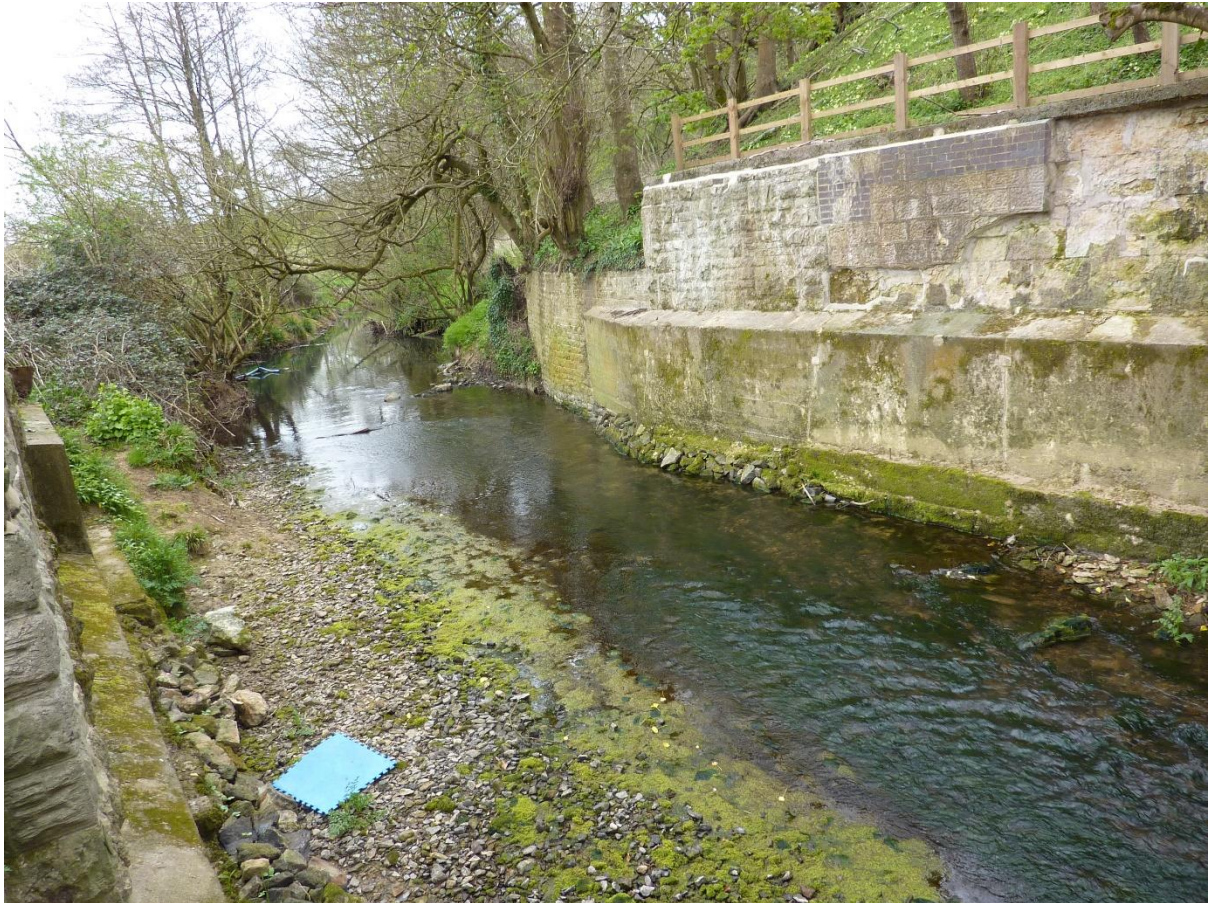
Figure 16: The shallow, exposed river channel through the old railway bridge footings would benefit from bankside cover (such as goat willows) on the RB

At ST 66929 33771, the footings of an old railway bridge (now partly demolished) were noted. Although the remaining footings have created a small upstream impoundment, the gradient drop downstream was not considered to be an obstacle to fish passage, apart from being rather exposed and lacking in marginal cover. To overcome this, the gravel bar on the RB could be further renaturalised by planting whips of goat willow, for future hinging into the margins for beneficial shade and cover.

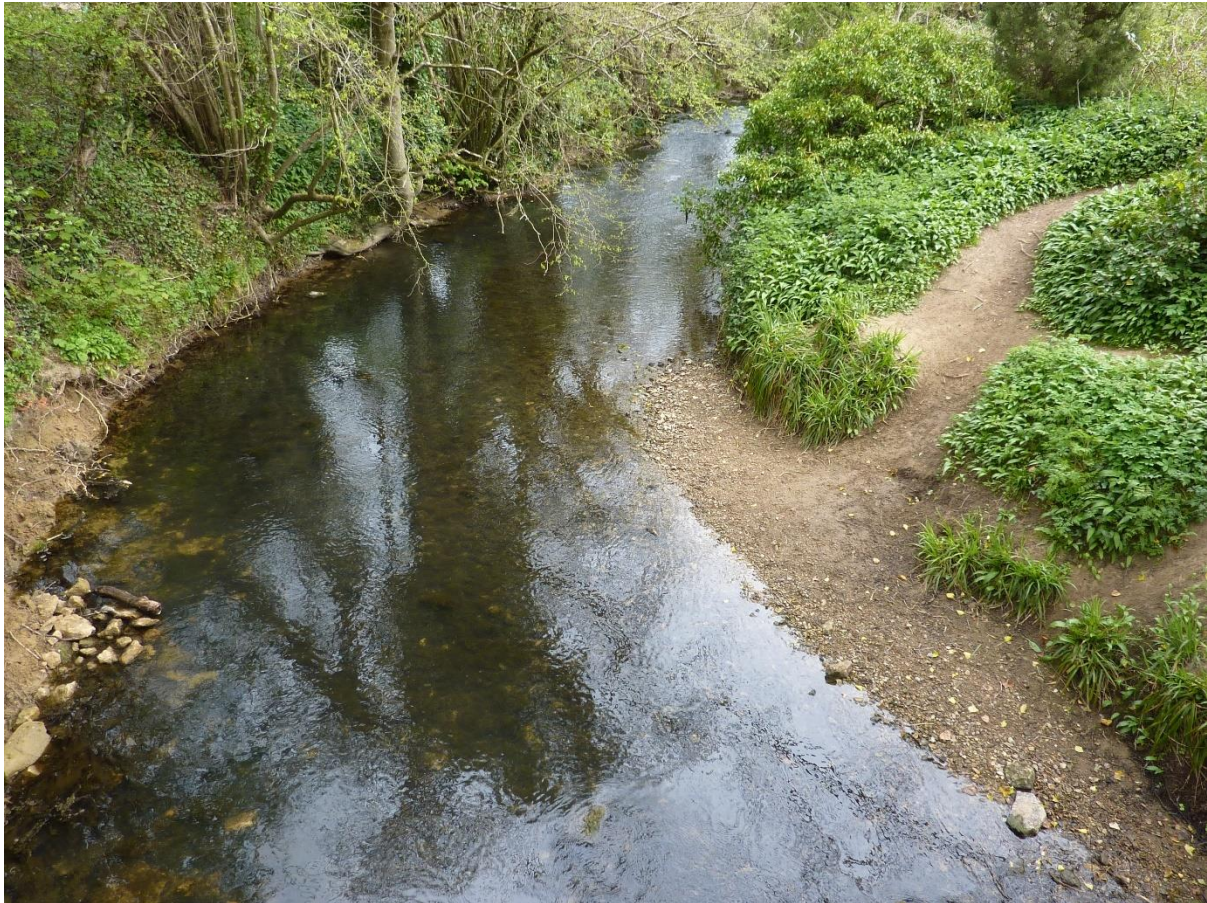
Figure 17: Looking upstream from Wyke Lane bridge, with a view of the 'beach' formed by deposition (and possibly access-related erosion) on the LB

As the River Brue curves between the bridges at Colestile Farm Lane and Wyke Lane, the channel becomes wider and shallower, with more obvious public access from the LB. A sloping 'beach' has formed in the margins of the river just upstream of Wyke Lane – possibly as a result of natural sediment deposition on the inside of bend, combined with footfall from people and dogs. (This is also understood to be the local riverfly monitoring site).

At present, footfall does not appear to be a very significant source of sediment input to the river in this area, but it should be monitored over time. 'Dog slides' where pets enter and leave the river via steep banks can cause very rapid, localised erosion: the best solution is usually to 'nudge' this activity towards areas of the bank which have been optimised for frequent footfall with access steps and gravel beaches retained by suitable logs, so as to resist erosion while offering safe access for all.

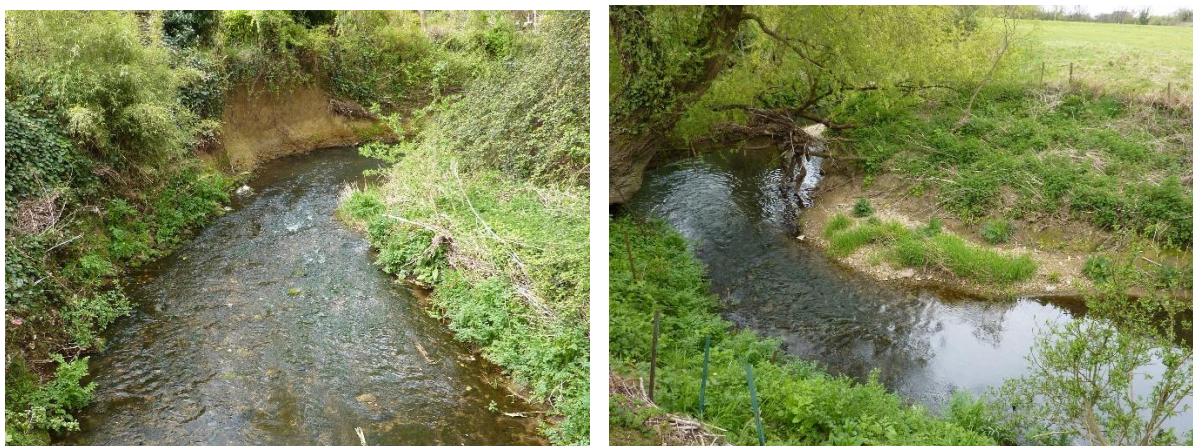
Figure 18: Varied pool and riffle habitat, with well-vegetated banks, alongside Cole Manor

Downstream of the Wyke Lane bridge at ST 66803 33741, the River Brue flows around the northern boundary of Cole Manor in a healthy natural sequence of pools and riffles.

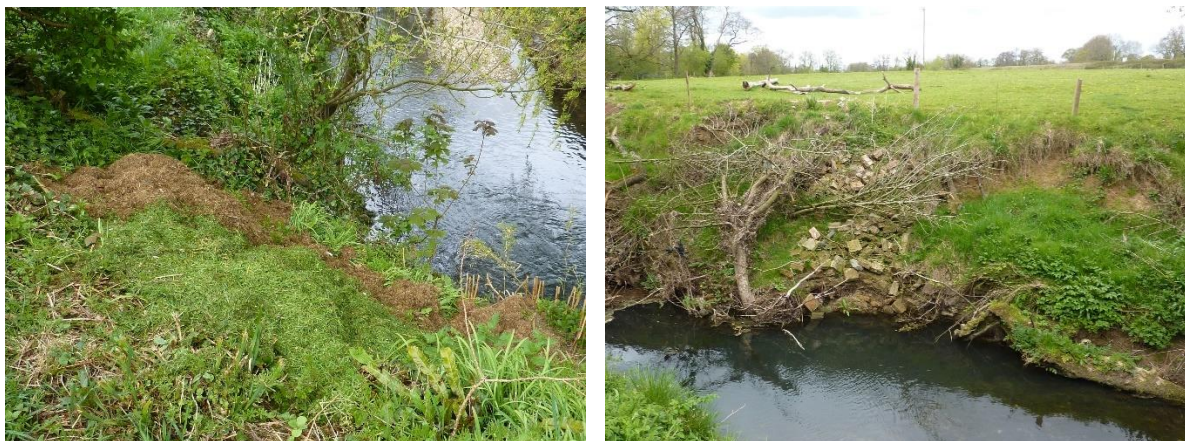
Figure 19: Disposal of grass clippings (left) and builder's waste in a counterproductive attempt to protect the bank (right) on the river banks should be avoided

Whilst walking along this stretch of river, at least one dumping area for grass clippings was found on the bank. As a general principle, disposal of grass clippings and other garden waste should always take place as far from a waterway as possible, since this plant material is likely to leach high levels of nutrients into the stream as it decomposes, potentially raising Biological Oxygen Demand (BOD) in

Although the RB of the river is not formally included in this survey, it was also noted that a quantity of builder's waste appeared to have been thrown down this bank, opposite the Cole Manor garden, at approximately ST 66750 33754. Apart from the negative aesthetic aspects of such rubbish disposal, builders' waste may contain contaminants which can damage the ecology of the watercourse. Even if this was designed to protect the bank where some light erosion and past 'slumping' was observed, it is most likely to prove ineffectual; a better approach would be 'green engineering' including HB control and planting goat willow whips and other deep-rooted native plants to help to stabilise the area. WTT would gladly engage with the landowner to explore appropriate options.

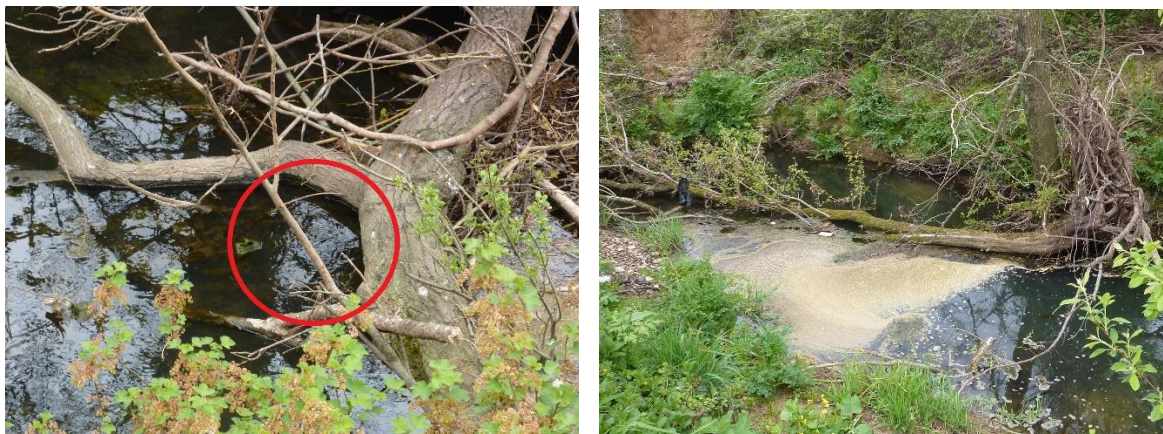
Figure 20: LWM producing undershot scour and upwelling currents (left, indicated by red circle); natural accumulation of organic surface scum (right)

As the river's course curves alongside the garden, several accumulations of LWM were noted in the channel. The general lack of LWM in many rivers (as explained previously) makes this 'large wood' a very valuable habitat resource; wild trout have been seen in this stretch, and it is likely that they will be using these tangles of wood as cover.

In such a deeply incised channel, even comparatively large trees are unlikely to cause flood risk: as such, every effort should be made to retain them in the river, rather than remove them for any reason. In the case of one large tree limb, noticeable 'upwelling' of water was seen on the downstream side – showing how, even in low flow conditions, LWM can initiate localised scour to clean gravels, create habitat pockets, and perpetuate the river's healthy sequence of pools and riffles.

In the course of conversation with the landowner, it was noted that some 'scum' had collected on the water's surface at the upstream sides of these 'log jams'. Although the location is downstream of Bruton STW, this scum was assessed to be a natural accumulation of organic material, including decomposing algae which

had floated up from the river bed in low water / warm weather conditions, and will be swept away in higher flows. However, any more significant signs of pollution such as odours, unusually coloured water (particularly at times of low flow), or distressed fish or wildlife, should always be reported to the Environment Agency's incident hotline as soon as possible: 0800 80 70 60.
