River Pitt: Pitcombe to Cole, Somerset

Advisory Visit April 2025

This report is the output of a visit undertaken by Theo Pike of the Wild Trout Trust on approximately 1.5 km (0.9 miles) of the River Pitt in Somerset, from Pitcombe downstream to Cole, on 14 April 2025.

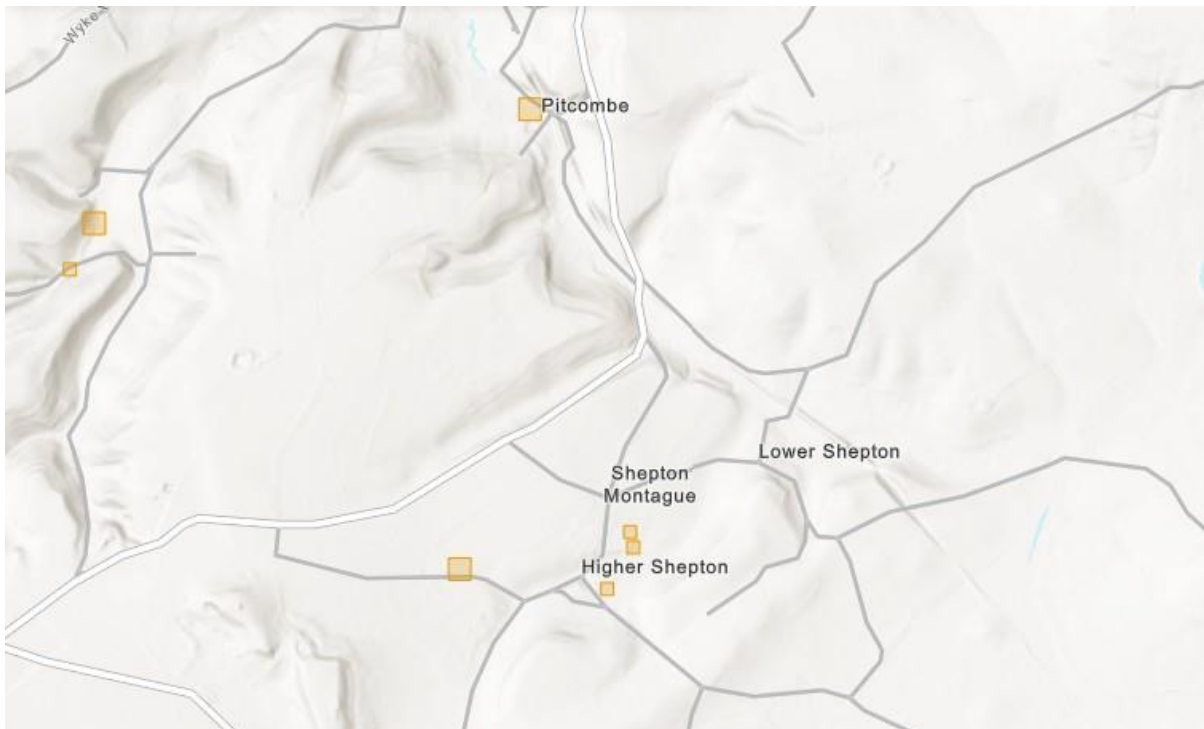
Figure 3: A map showing treated sewage discharge locations in the upper Pitt catchment. Source: <https://theriverstrust.org/sewage-map>

These sources could include farm runoff, misconnections from domestic properties (when e.g. washing machines are mistakenly plumbed into rainwater pipes), and improperly-maintained septic tanks. The Rivers Trust's Sewage Map also shows a number of small, apparently unmonitored discharge points for treated sewage in the Shepton Montague area of the Pitt's upper catchment, so it may be worth investigating the performance of these sites with Wessex Water, or via a citizen science water testing scheme (including participation in the Brue CREW's wider riverfly monitoring programme).
